Modeina Estate - Stage 33, Burnside

Level 1 Inspection & Testing Report

Reference: 1120 0379-1

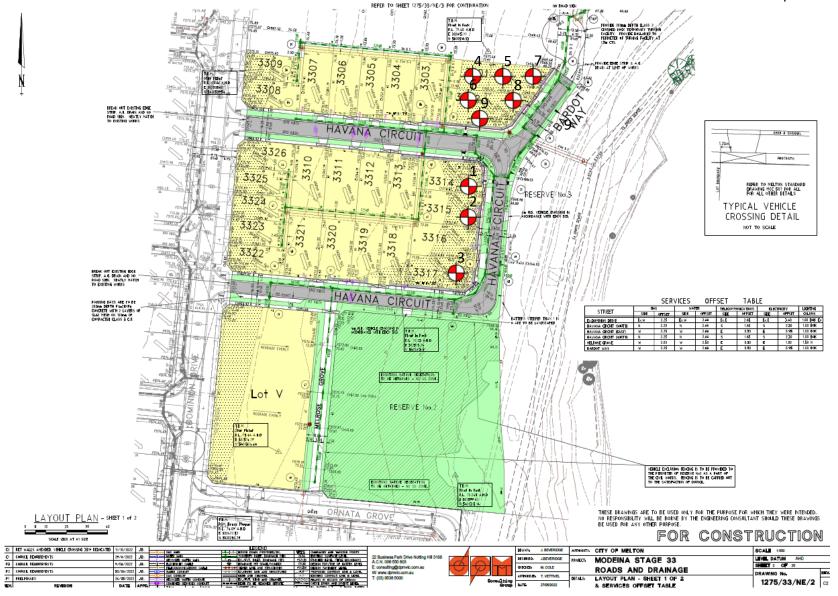
Appendix B – Test Locations

The locations of the 9 field density tests are shown in Appendix B – Test Locations. A summary of the test results obtained from the field density testing is presented in Appendix C – Test Results Summary. The laboratory test reports of the field density tests are presented in Appendix D – NATA Test Results.
