Modeina Estate - Stage 22, Burnside (Level 1)

Level 1 Inspection & Testing Report

Reference: 1120 0252-1

November 2021

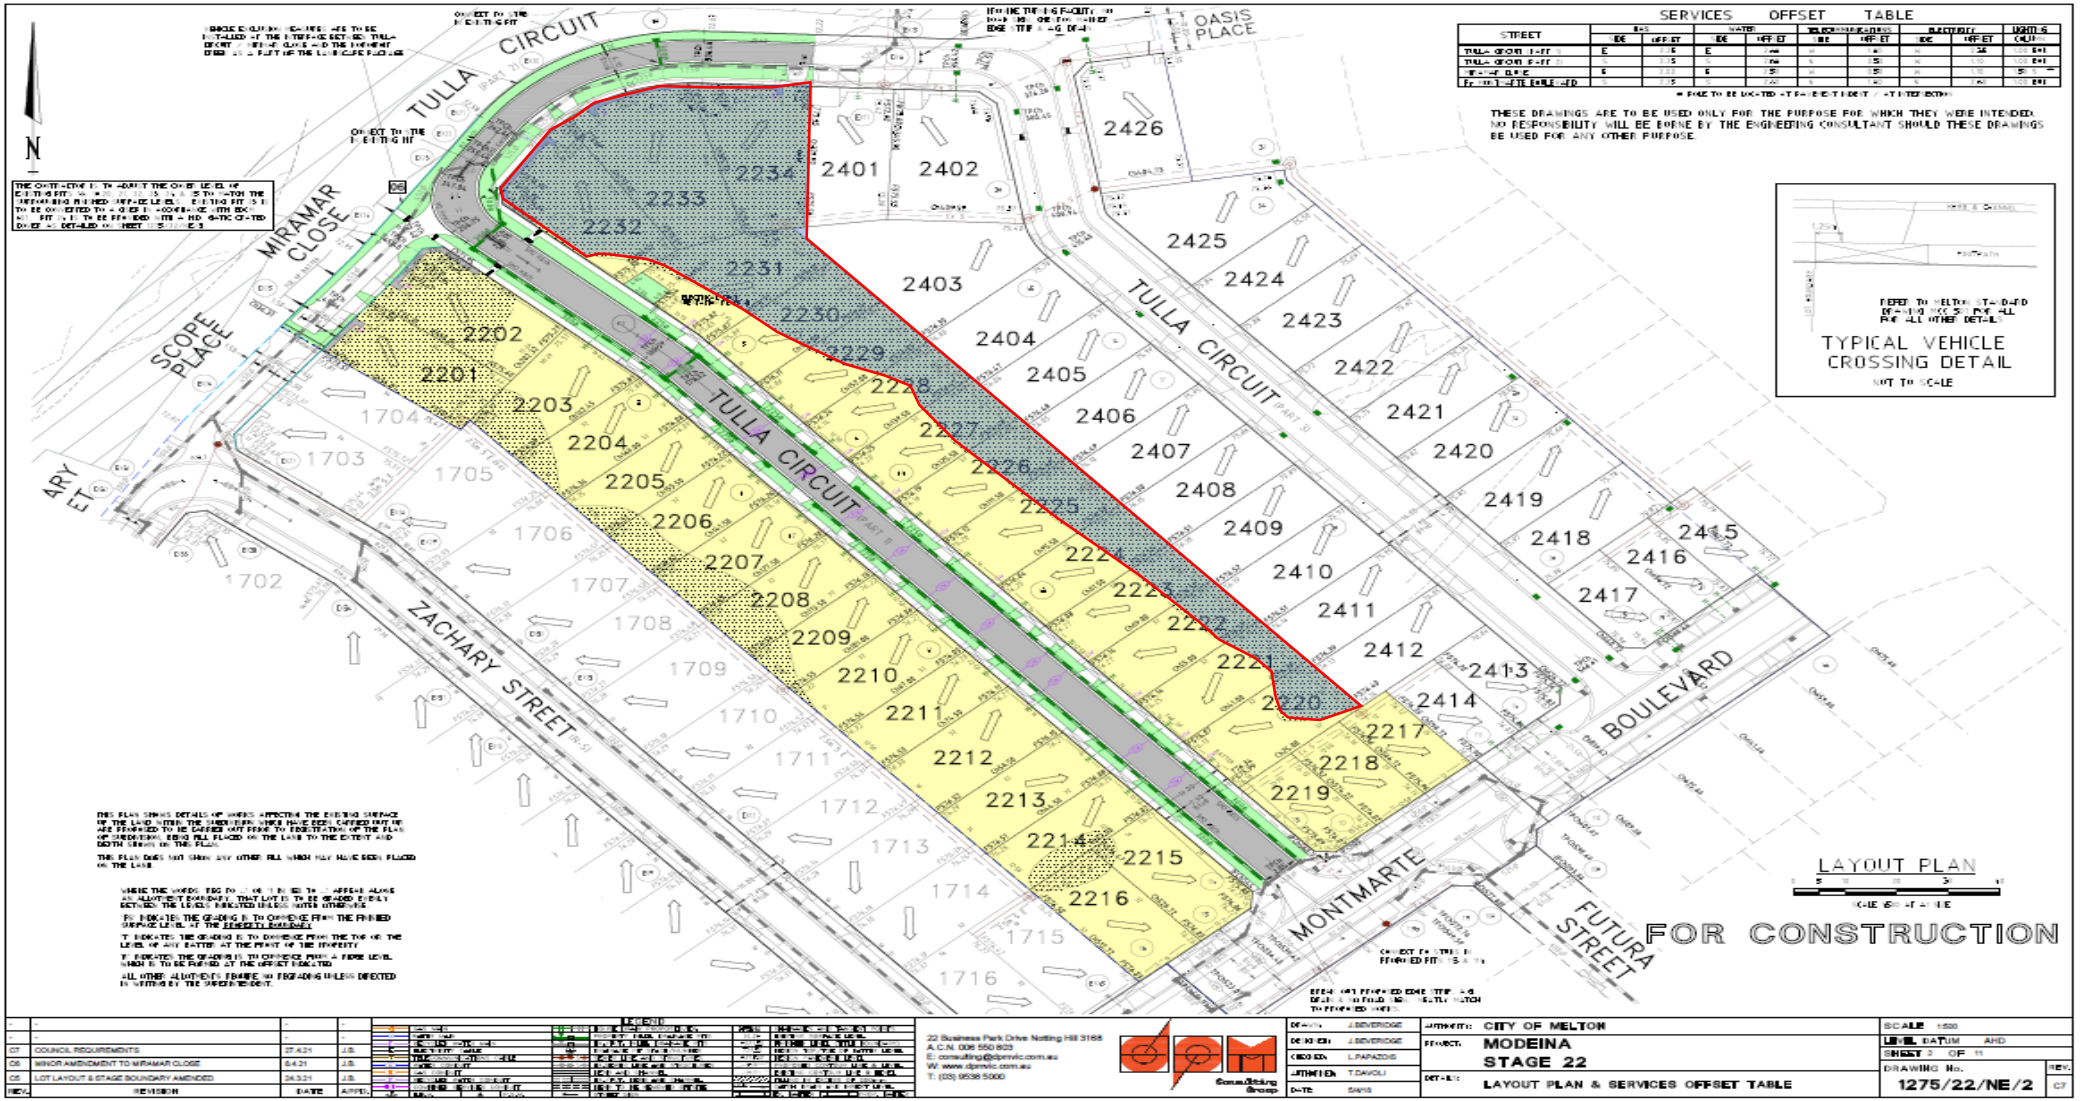
Appendix A - Site Plan

This report is applicable for fill placed by DFC (Project Management) Pty Ltd for the shaded areas at the following lots located in Modeina Estate - Stage 22 - Burnside, as shown in Appendix A – Site Plan.

- Lot 2220 - 2234

Area Inspected and Tested on 22/06/2021

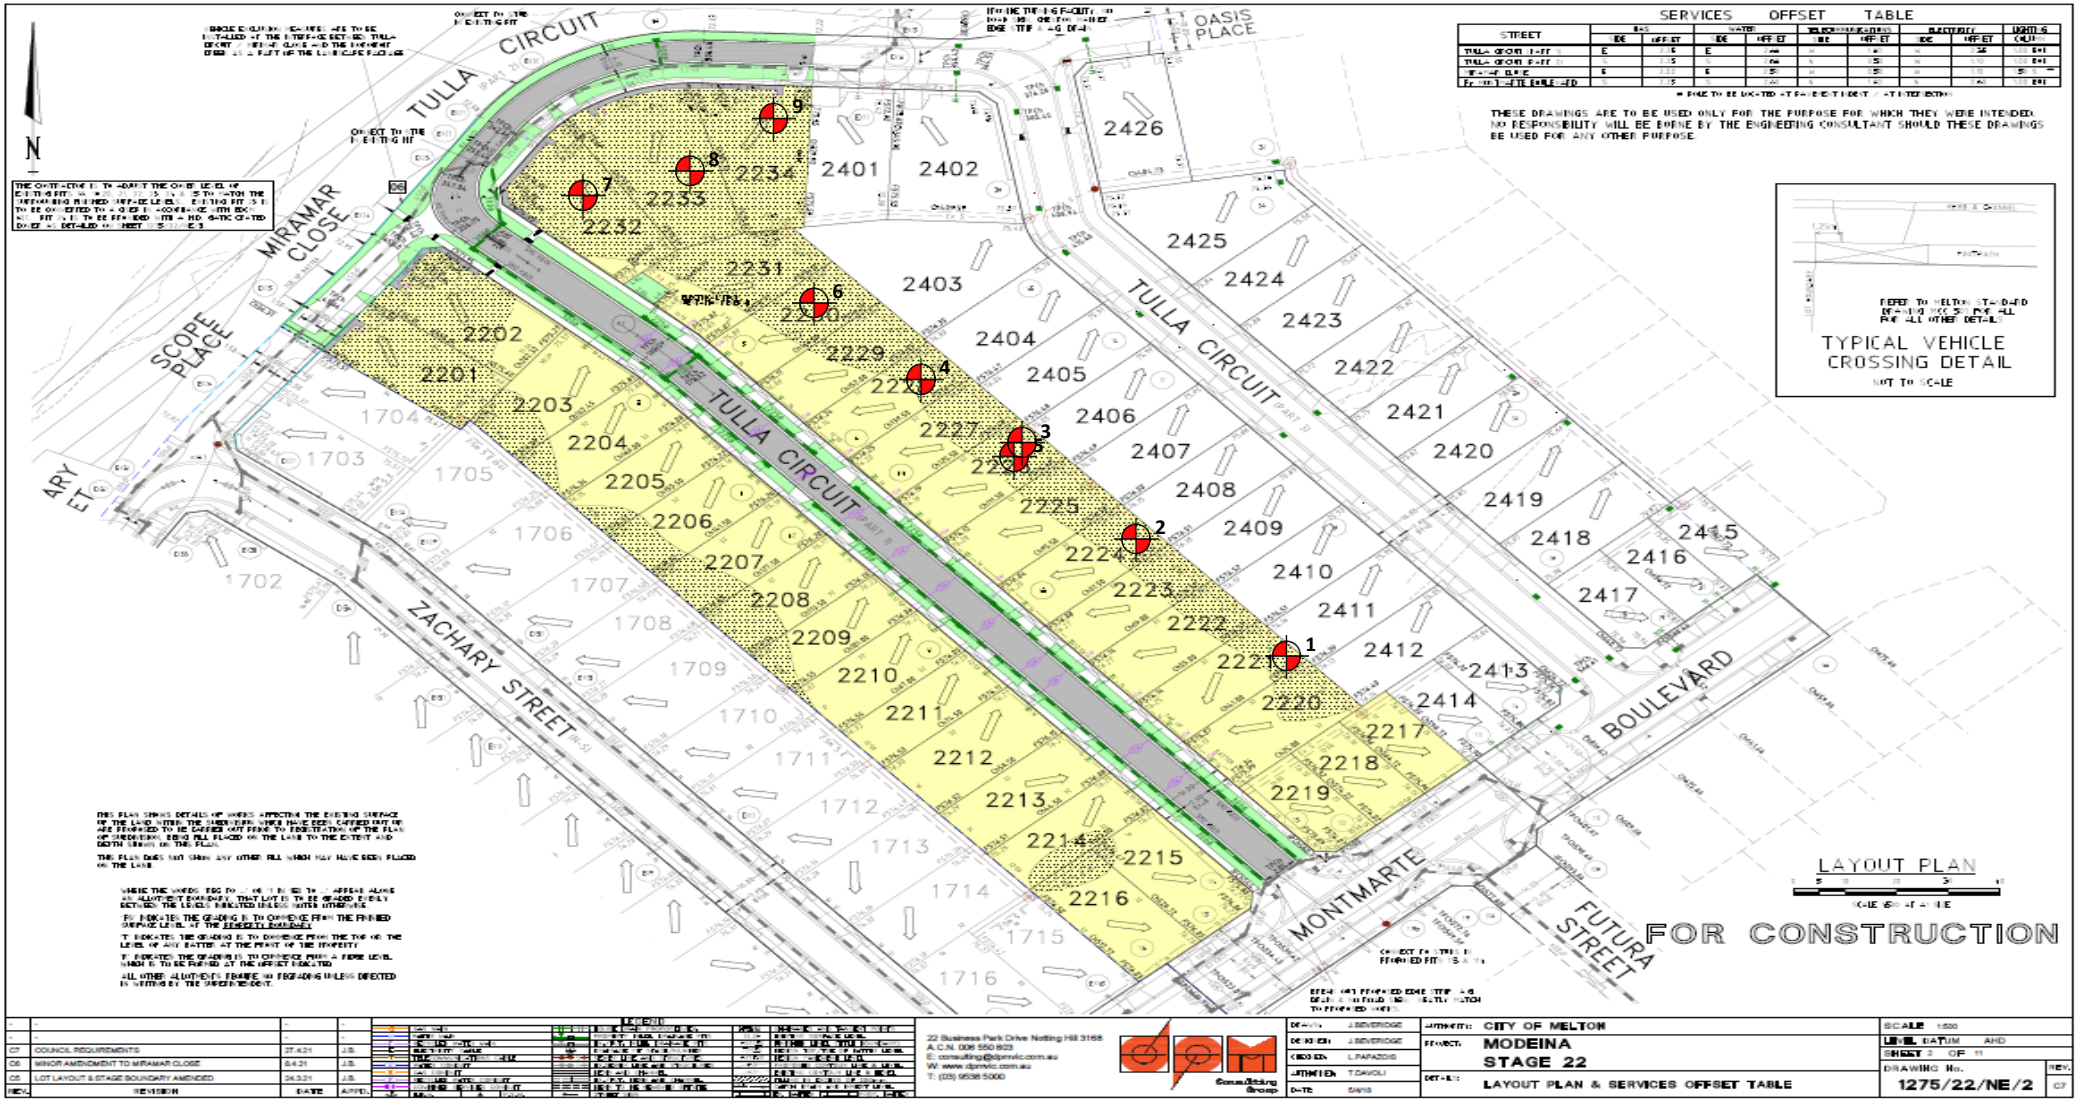
Appendix B – Test Locations

The locations of the 9 field density tests are shown in Appendix B – Test Locations. A summary of the test results obtained from the field density testing is presented in Appendix C – Test Results Summary. The laboratory test reports of the field density tests are presented in Appendix D – NATA Test Results.

Indicative Test Location

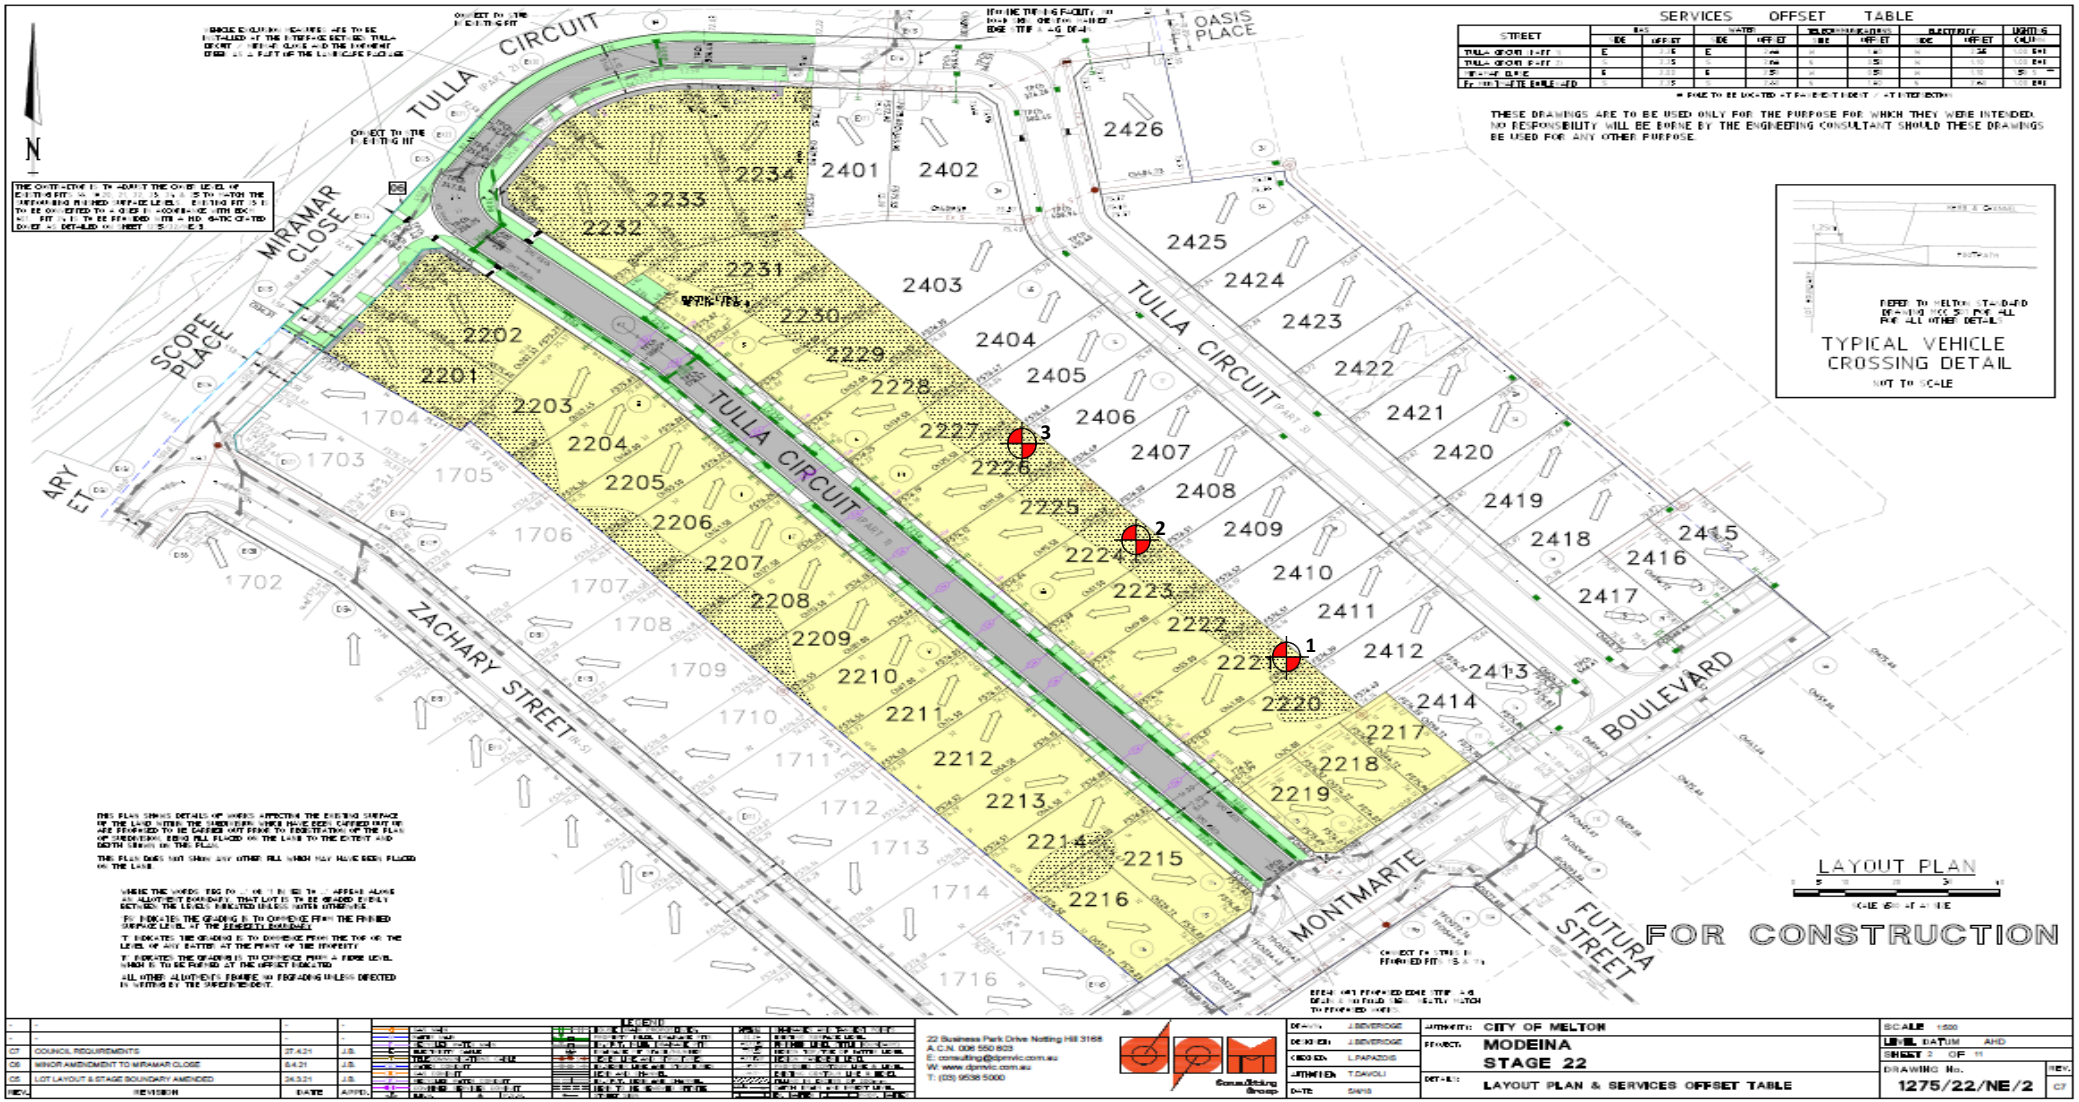
Sample No		1	2	3			
Date Tested		22/06/2021	22/06/2021	22/06/2021			
Time Tested		AM	AM	PM			
Test Location		Refer to Plan	Refer to Plan	Refer to Plan			
Level/Layer		1	1	FSL			
Layer Thickness	mm	150	150	150			
Test Depth	mm	125	125	125			
Field Wet Density	t/m^3	1.85	1.83	1.81			
Field Moisture Content	%	26.6	25.9	25.1			
Material:		Site Derived Clay	Site Derived Clay	Site Derived Clay			
Oversize Material	WET, %	3.5	0.0	0.0			
Sieve Size	mm	19	19	19			
Peak Converted Wet Density	t/m^3	1.93	1.92	1.89			
Optimum Moisture Content	%	29.5	28.5	28			
Moisture Ratio	%	90	91	89.5			
Moisture Variation from OMC	%	-3.0 Drier	-2.5 Drier	-3.0 Drier			
Density Ratio	%	95.5	95.0	95.5

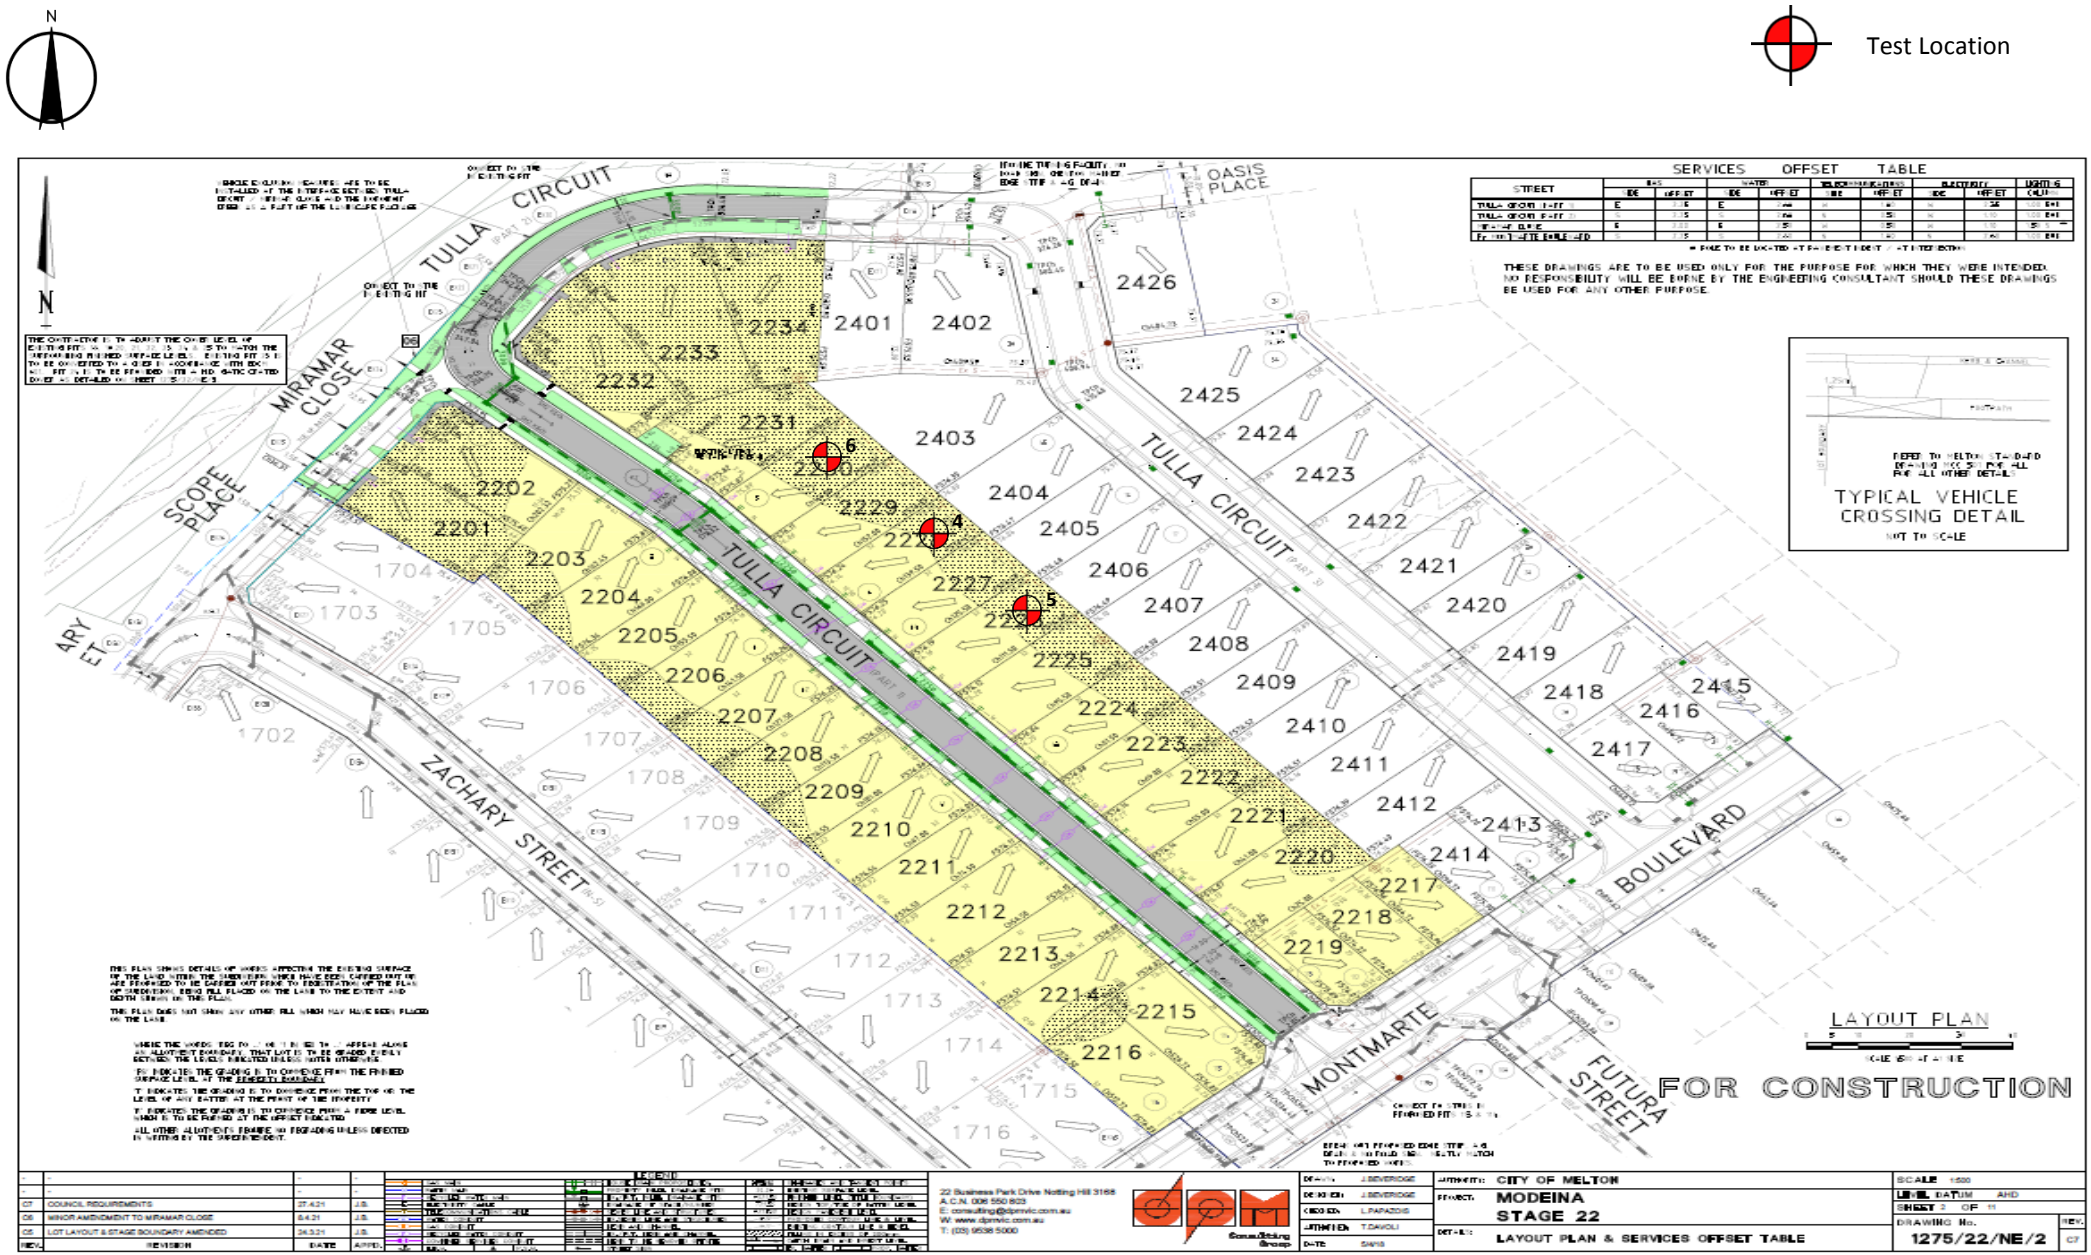
Sample No		4	5	6			
Date Tested		23/06/2021	23/06/2021	23/06/2021			
Time Tested		PM	PM	PM			
Test Location		Refer to Plan	Refer to Plan	Refer to Plan			
Level/Layer		2	2	1			
Layer Thickness	mm	200	200	200			
Test Depth	mm	175	175	175			
Field Wet Density	t/m^3	1.90	1.97	1.98			
Field Moisture Content	%	27.9	27.3	26.9			
Material:		Site Derived Clay	Site Derived Clay	Site Derived Clay			
Oversize Material	WET, %	0.0	0.0	0.0			
Sieve Size	mm	19	19	19			
Peak Converted Wet Density	t/m^3	1.97	1.98	2.04			
Optimum Moisture Content	%	29	28	27			
Moisture Ratio	%	96	97.5	99.5			
Moisture Variation from OMC	%	-1.0 Drier	-0.5 Drier	0.0 OMC			
Density Ratio	%	96.5	99.5	97.0
