Modeina Estate – Stage 24, Burnside

Level 1 Inspection & Testing Report

Reference: 1120 0295-1

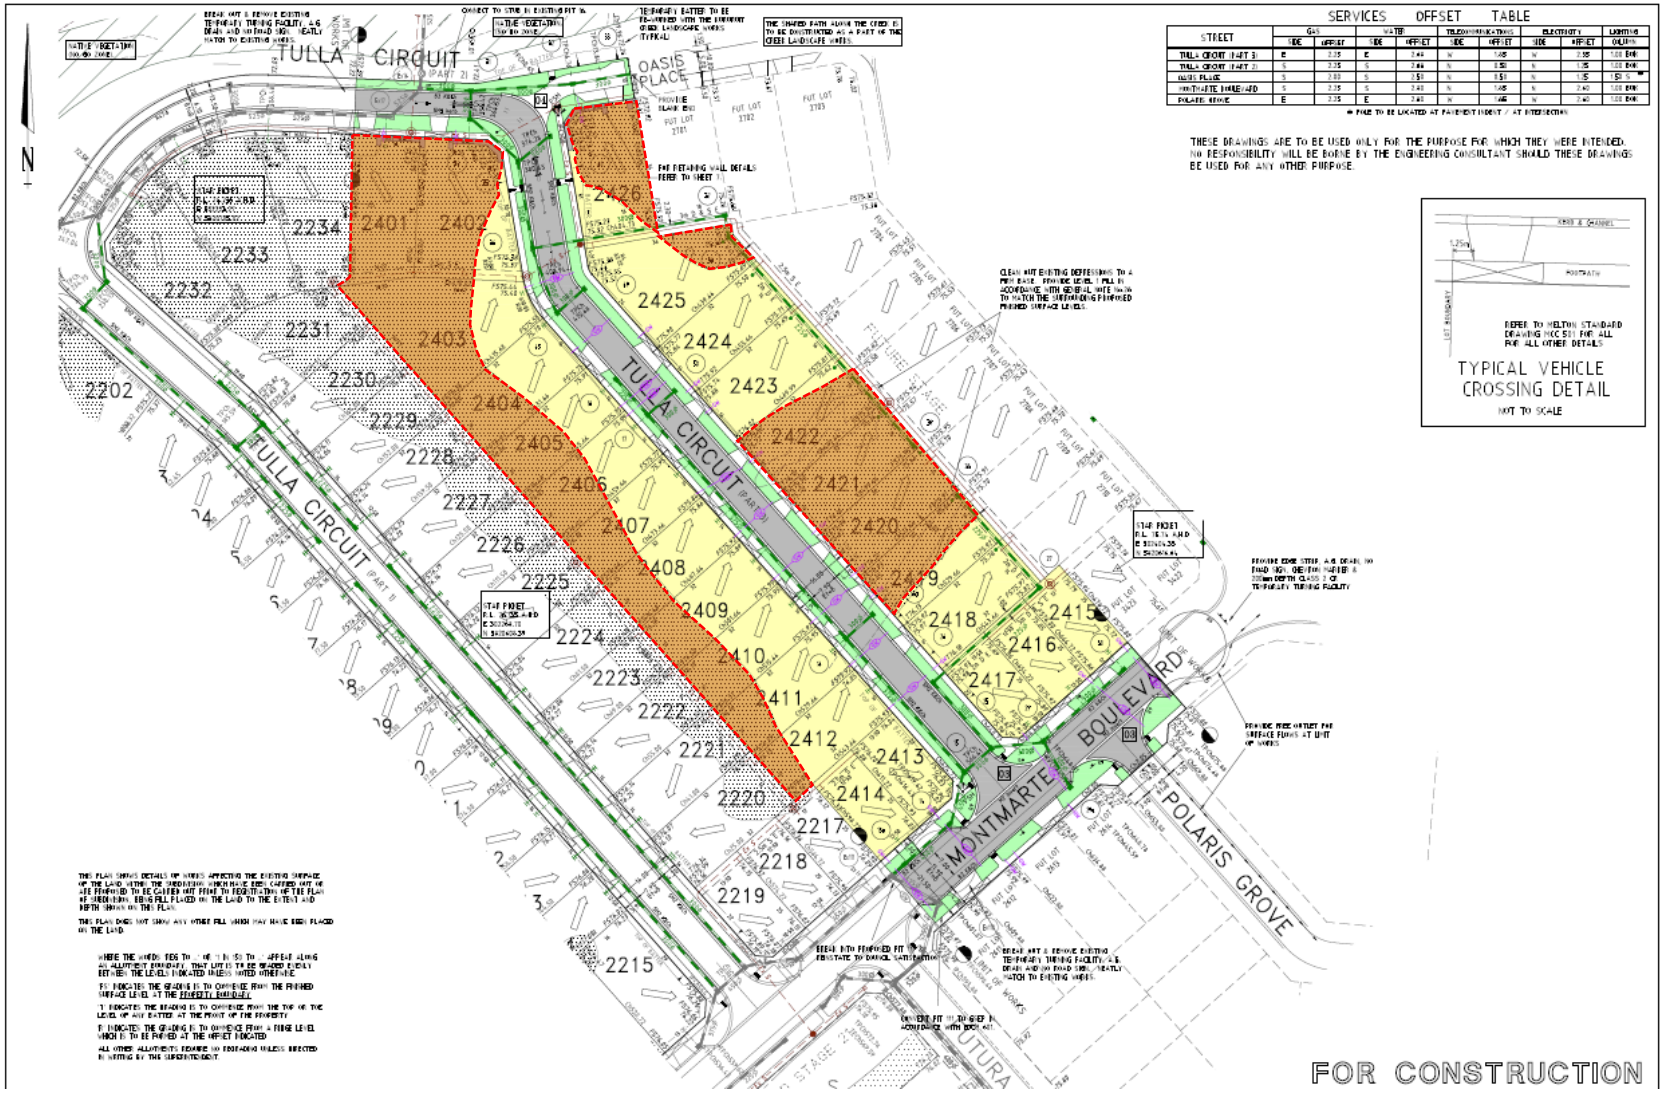
Appendix A - Site Plan

The exposed subgrade material comprised natural silty clay. No wet or soft patches were found during the inspection. No evidence of deleterious material was found during the inspection.

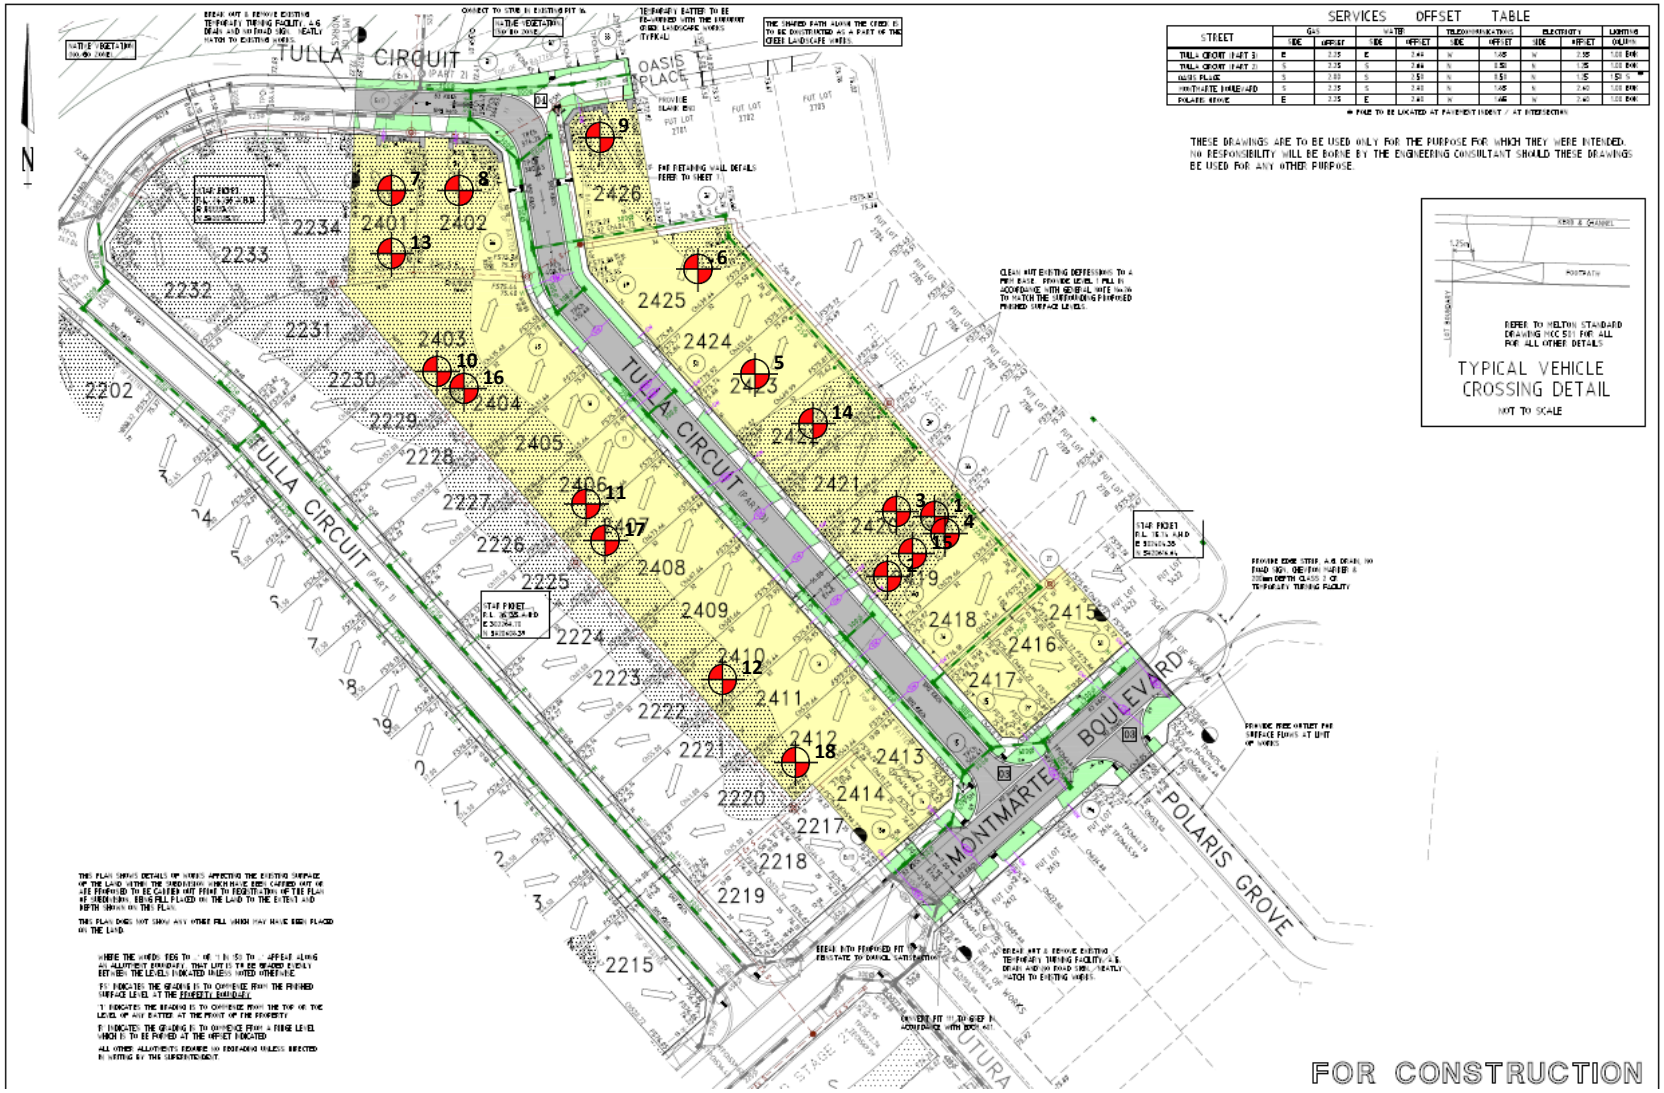
Indicative Test Location

The locations of the 18 field density tests are shown in Appendix B – Test Locations. A summary of the test results obtained from the field density testing is presented in Appendix C – Test Results Summary. The laboratory test reports of the field density tests are presented in Appendix D – NATA Test Results.

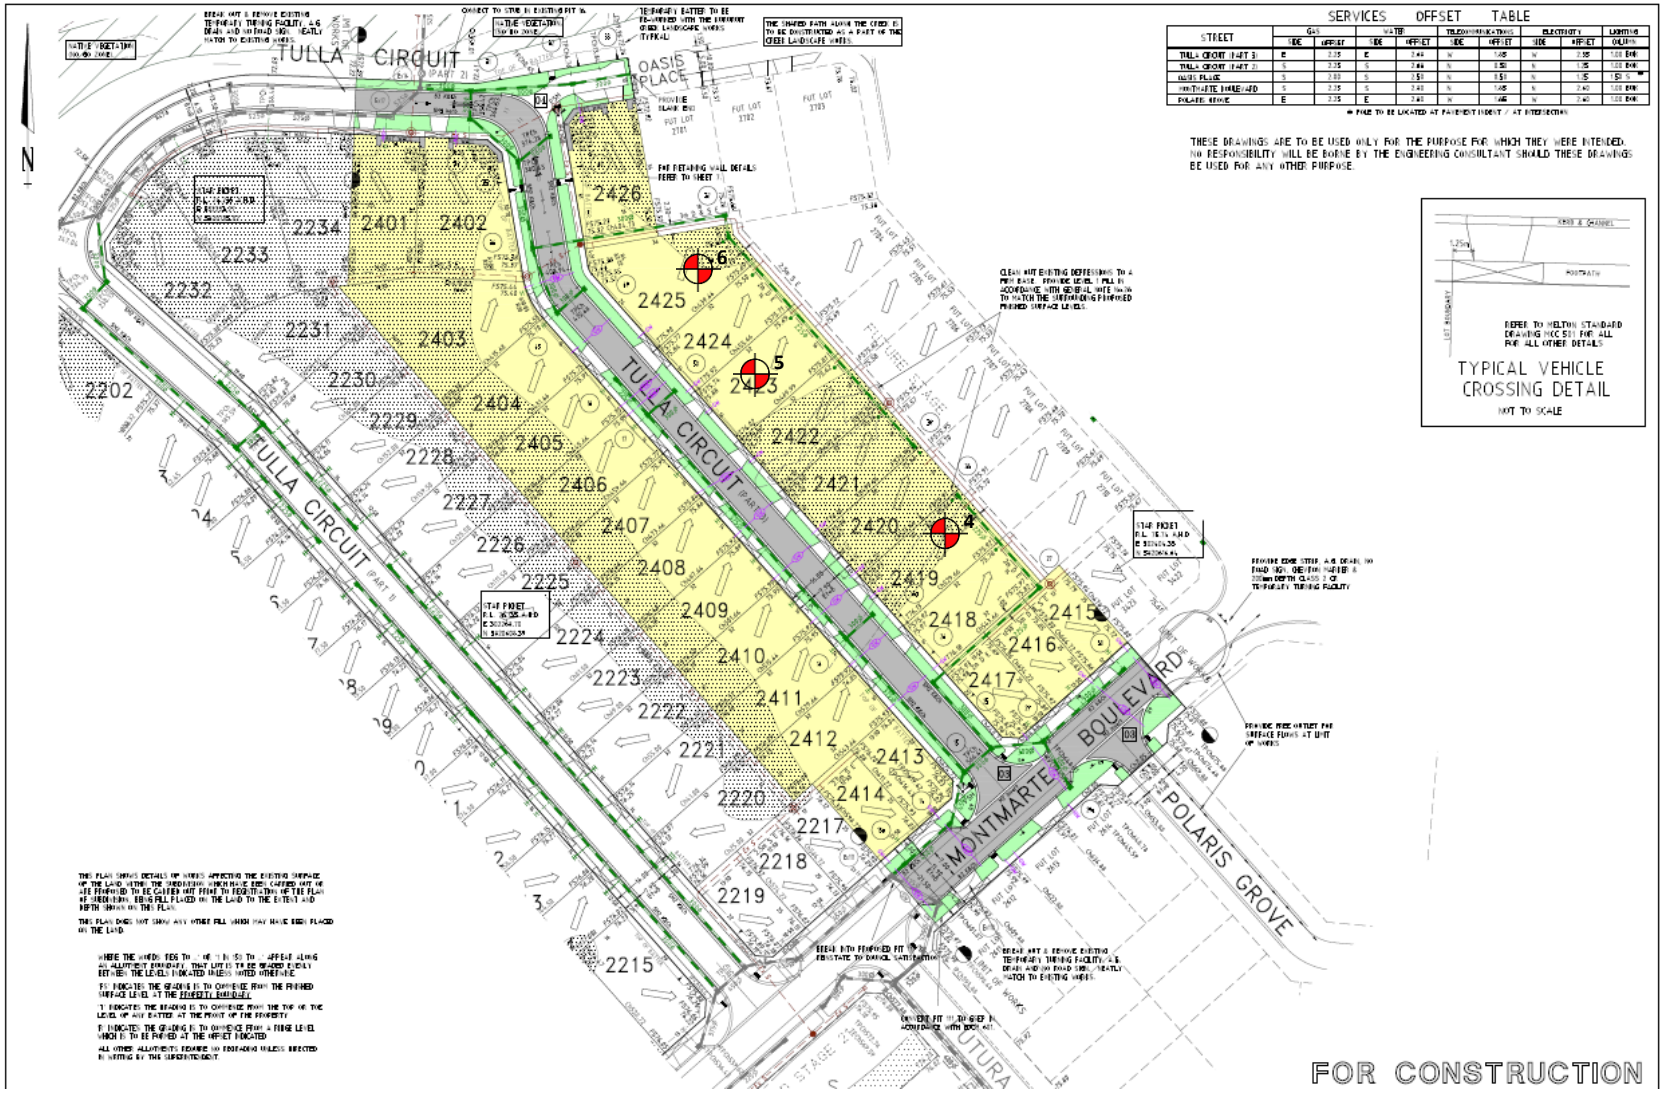
PROJECT: Modeina Estate – Stage 24 (Level 1)	**CLIENT:** Excell Gray Bruni	**DATE:** 10/12/2021	A&Y ASSOCIATES GEOTECHNICAL ENGINEERING CONSULTANTS
LOCATION: Burnside	**PROJECT No:** 1120 0295-1 (SI02)	**SITE PLAN SKETCH—NOT TO SCALE**

Sample No		4	5	6			
Date Tested		10/12/2021	10/12/2021	10/12/2021			
Time Tested		AM	AM	AM			
Test Location		Refer to Plan	Refer to Plan	Refer to Plan			
Level/Layer		FSL	FSL	FSL			
Layer Thickness	mm	150	150	150			
Test Depth	mm	125	125	125			
Field Wet Density	t/m^3	1.81	1.99	1.89			
Field Moisture Content	%	24.3	23.8	24.5			
Material:		Site Derived Clay Fill	Site Derived Clay Fill	Site Derived Clay Fill			
Oversize Material	WET, %	5.0	6.0	4.0			
Sieve Size	mm	19	19	19			
Peak Converted Wet Density	t/m^3	1.84	2.03	1.96			
Optimum Moisture Content	%	25	24	25			
Moisture Ratio	%	97	99	98			
Moisture Variation from OMC	%	-0.5 Drier	-0.5 Drier	-0.5 Drier			
Density Ratio	%	97.0	97.0	96.0
